## The Lesson of the Quebec Bridge

Wilfred G. Lockett

## THE LESSON OF THE QUEBEC BRIDGE

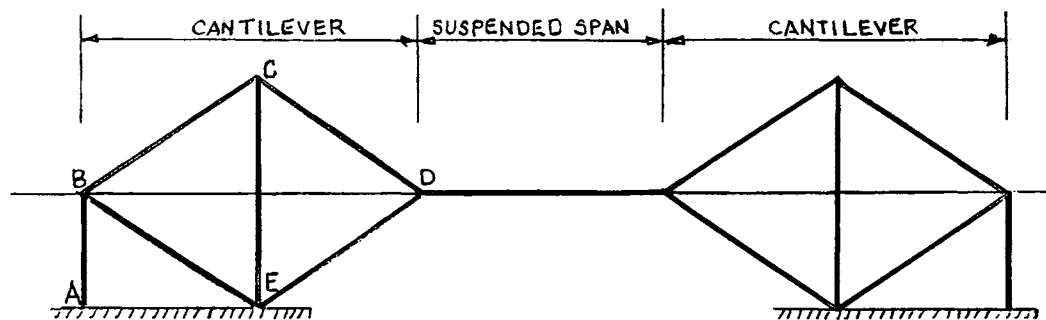
Figure 3

The fundamental elements of the cantilever structure are shown on Figure 3, and comprise essentially a bracket, jutting out from a tower which is prevented from overturning by a similar bracket firmly anchored to a solid foundation. A pair of these structures support between them the suspended span which completes the crossing of the river. We will later have to consider some of the basic engineering involved in the design of the structure, but in the meantime we should note that the upper members of the cantilever are in tension, while the lower members act as struts and are in compression.

Anchor Post AB.....in tension  
 Upper Chord BC, CD.....in tension  
 Central Tower CE.....in compression  
 Lower Chord BE, ED.....in compression

THE CANTILEVER PRINCIPLE

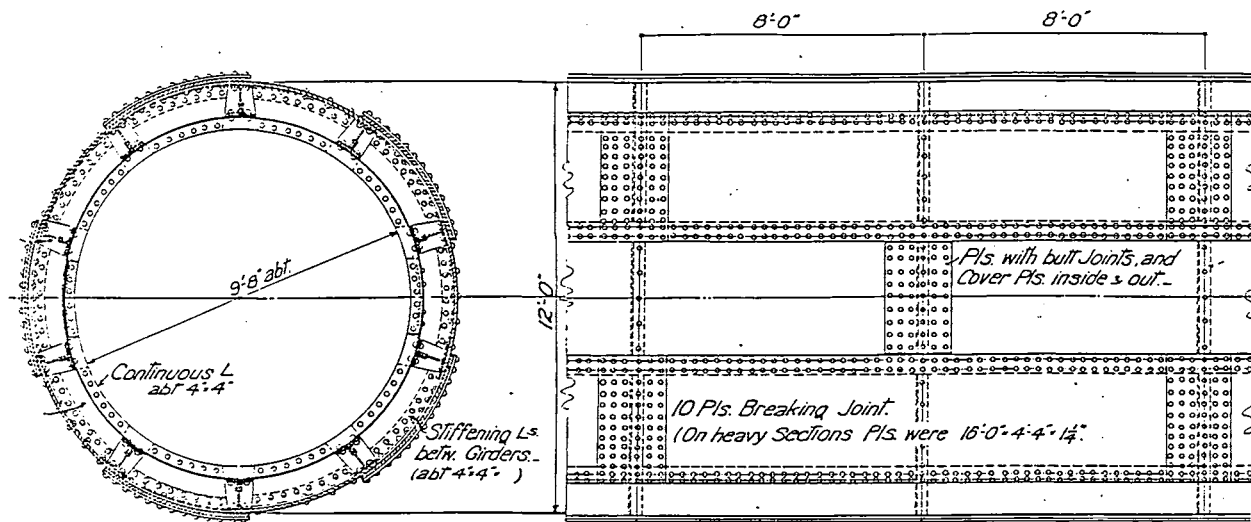
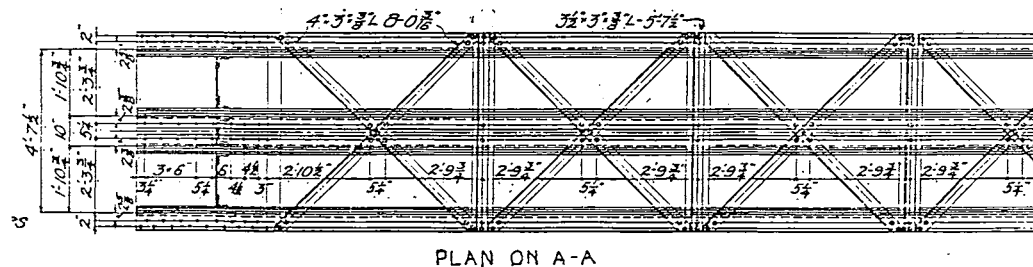
FIGURE 5

We have now to consider the design of the compression members and in particular those of the lower chord, that part of the cantilever incorporating the distinct curve shown in Figure 2(b). As noted above, the strength of a compression member or strut depends principally on its resistance to buckling. In the case of the Forth bridge this was neatly accomplished by giving the members a cylindrical form, which during the erection stage involved the building up of the member curved plate by curved plate, a procedure well suited to the skills of Scottish shipwrights. But in North America the accepted practice was to use standard rolled steel sections (angles, flats, I-beams, etc.) in the fabrication of structural members. In the Quebec bridge the struts were built up from an array of parallel flat plates. Figure 5 shows a comparison of the compression members of the Forth and Quebec bridges. The bracing introduced for stiffening the latter may be clearly seen. The active cross-sectional area was about 800 square inches in Forth bridge and 842 square inches in the Quebec bridge.

(a) FORTH BRIDGE COMPRESSION MEMBER - SECTION AND ELEVATION

(b) QUEBEC BRIDGE COMPRESSION MEMBER

While the last paragraph of Inglis's comments referred to the second Quebec bridge, it could equally be applied to the first. In the all-important matter of the compression members we have noted (with Inglis) that the tubular struts of the Forth bridge were tailor-made plate by plate. There was at least one precedent for this: the massive elliptical tubes which formed the arch elements in I.K. Brunel's Tamar bridge (opened 1859). It would probably be fair to say that the prefabricated struts of the Quebec bridge involved a far greater departure from previous experience than in the British case. The minimum dimensional tolerances which could be achieved in practice left room for

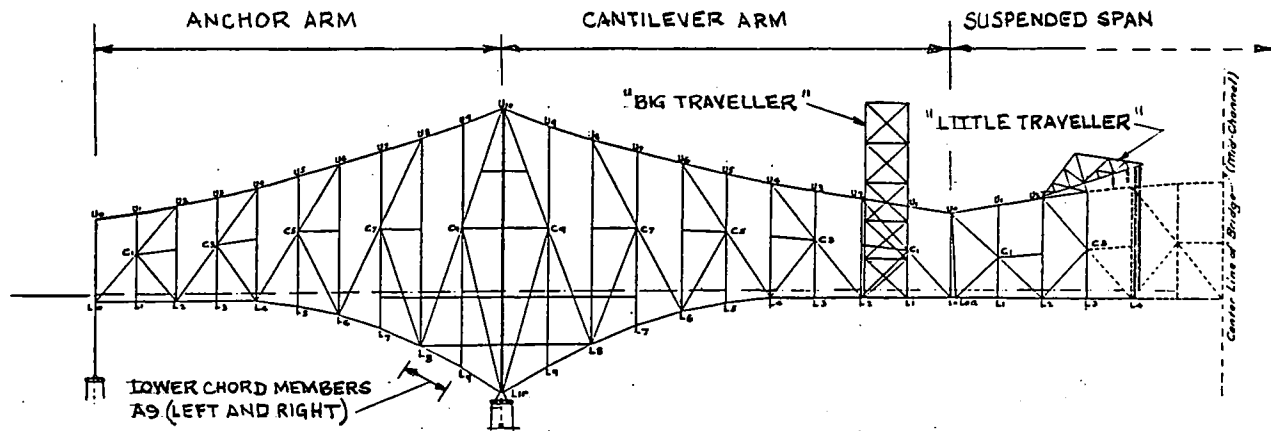
FIGURE 6

By August, 1907, construction had reached the stage where the south cantilever had been completed and erection of the suspended span, jutting out from the end of the cantilever, was in hand. The 'big traveller,' a movable gantry used in the handling of components, was being dismantled in anticipation of transferring it to the north bank, and a 'little traveller' was in use for the work on the suspended span (see Figure 6).

CONDITIONS ON AUGUST 29, 1907

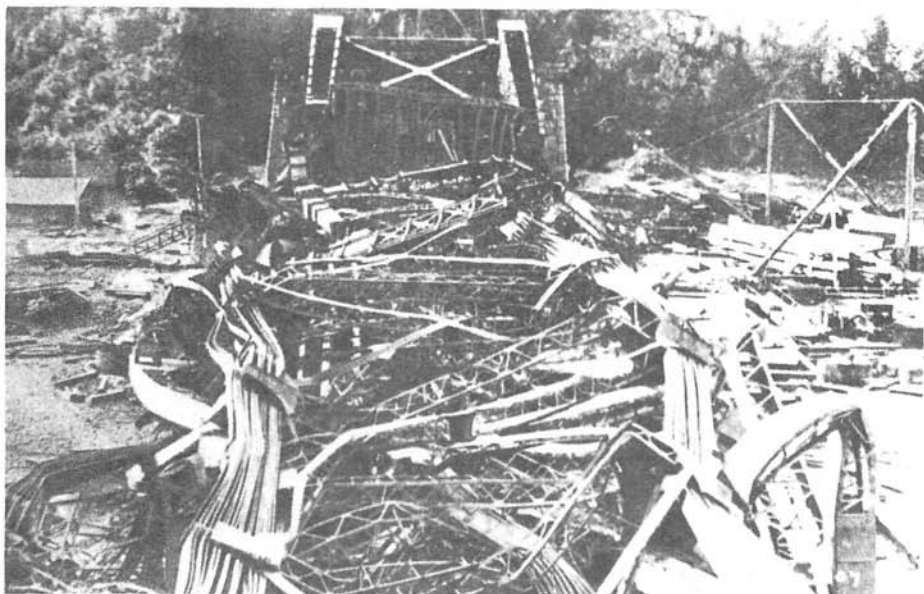
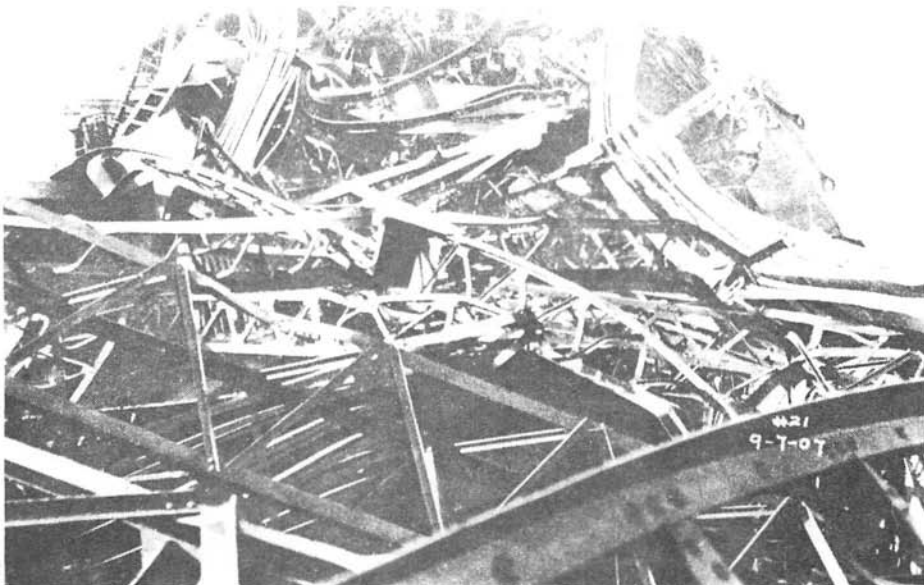
Cooper instructed McLure to discuss the problem with Deans. McLure's arrival in Phoenixville, at about 5.00 pm on Thursday, 29 August, coincided with the collapse into a tangled heap of the whole superstructure, taking the lives of 74 men, including Yenser and Birks. (Figures 7)

Figure 7(a) Wreckage, looking south [top]; 7(b) looking north

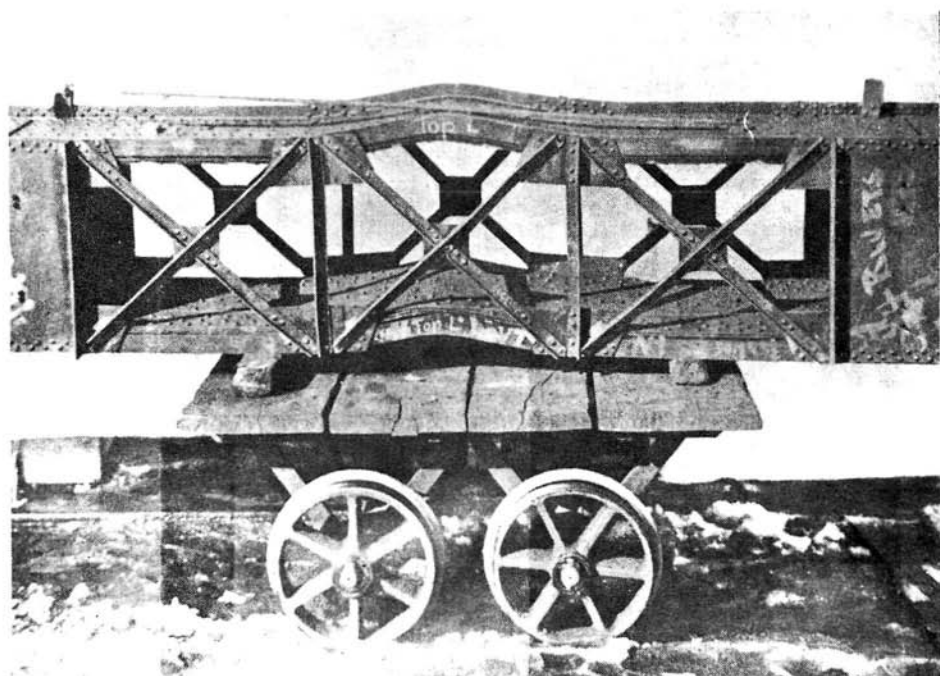
built and tested a model of the A9 chords, scaled down to 1/3 full size to bring it within the capacity of the machine. Subsequently other models were made and tested at the request of the Commission. The tests clearly demonstrated how, for the load-bearing webs to buckle, the latticing must fail first. (Figure 8)

Figure 8: Test of model chord
